Existing Conditions Assessment for
SAUNDERS HOUSE

GLOUCESTER LYCEUM & SAWYER FREE LIBRARY

Spencer, Sullivan & Vogt
ARCHITECTURE • PRESERVATION

GLOUCESTER, MASSACHUSETTS
NOVEMBER 2018

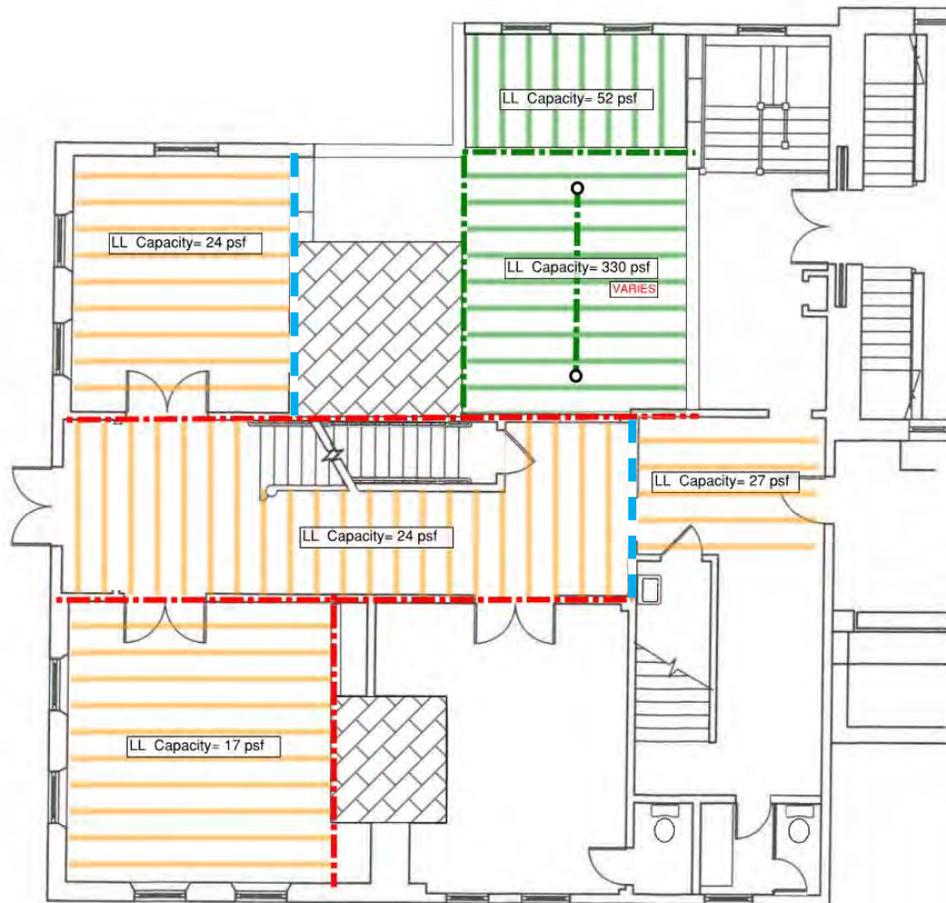
FIRST FLOOR FRAMING ON FIRST FLOOR PLAN

Beyond just the limitations of the floor framing, the plank walls that flank the central stair hall significantly limit the ability to simultaneously utilize the second and third floors without extensive reinforcement. The most conventional way to reinforce these walls is simply to re-frame them, however the presence of their painted murals makes this untenable. Therefore a system of added beams and columns would be needed.

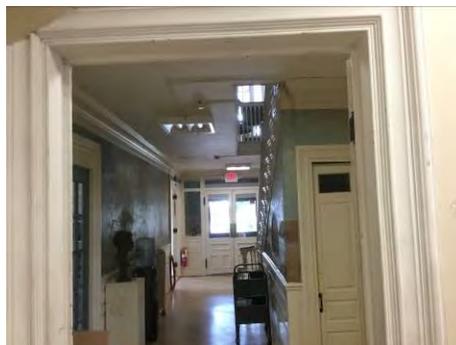
Existing Emergency Lighting & Exit

The existing emergency lights and exit signs are in good condition; however, they do not provide full coverage at egress paths.

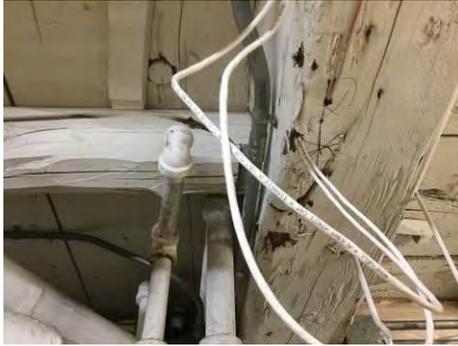
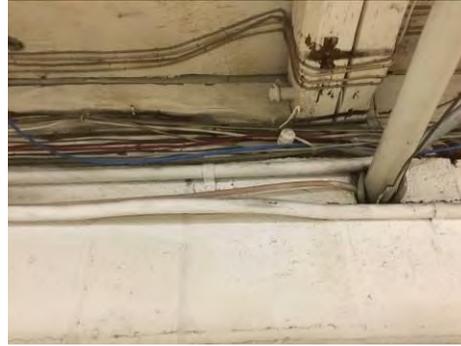
Cabling

The MDF/IDF is located in the main building. The cabling is not neatly dressed and secured.

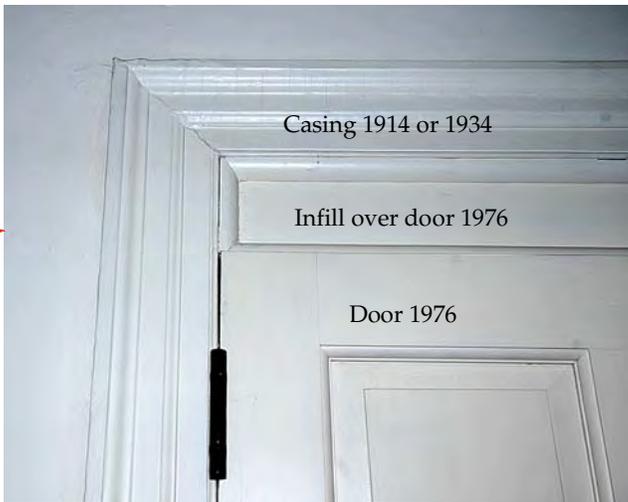
4.6: Detail of expedient installation of replacement doors using stock material in 1976.

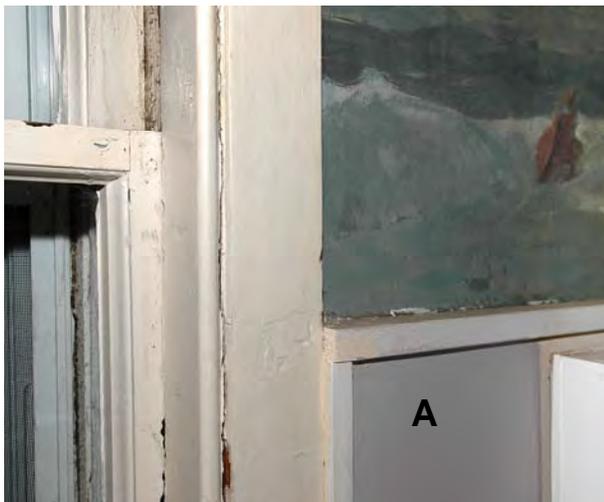
10.4: Detail at junction of mural to the lower wall and window casing. Wallboard (A) was applied over the lower portion of the wall plaster in 1976 as an expedient repair, but the murals were apparently painted directly on the old plaster. The plain board window casings is typical of most 2nd floor casings from both 1764 and 1878.

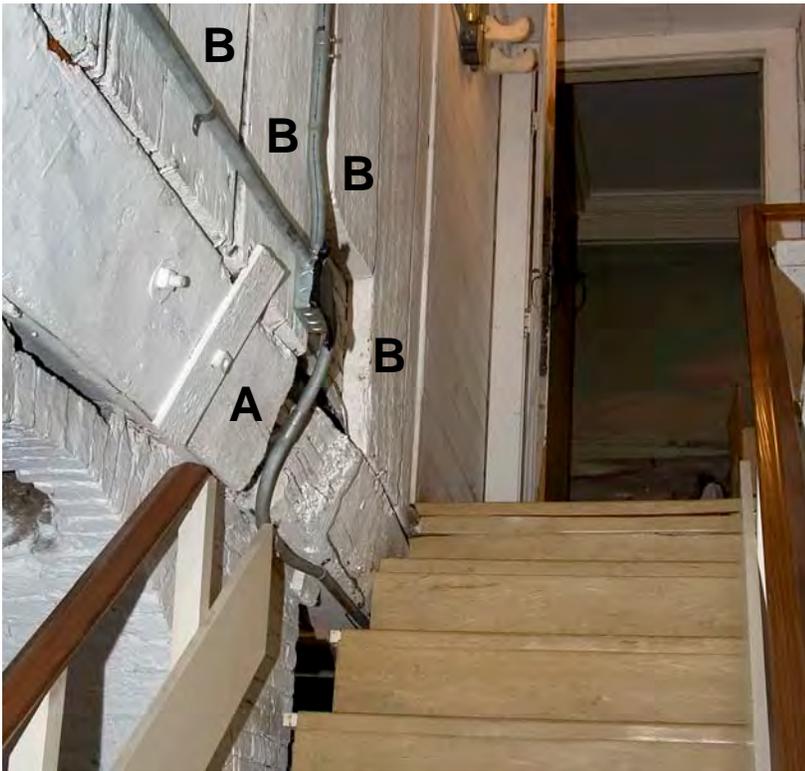
14.1: Severely twisted and split beam (A) under main stair hall west wall. "B" marks wall planks that bear on the beam and have been pushed outwards by the twisting of the beam (see 14.4). This condition was documented several years ago in an engineering report by Ocmulgee Associates of Ipswich, MA.

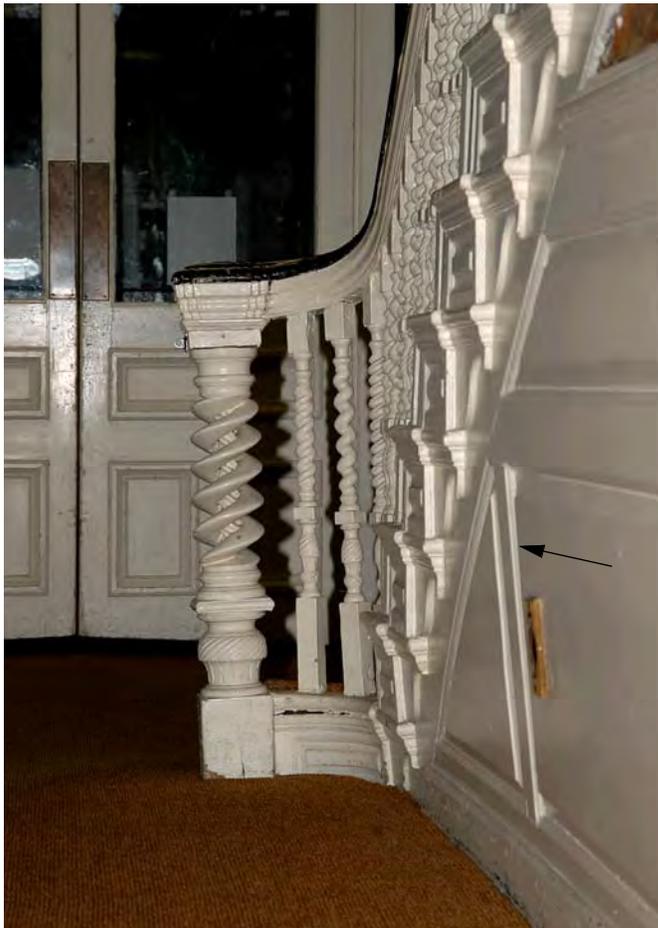
14.6: Bulge in stair woodwork (arrow) may be due to the movement of the plank wall over the twisting cellar beam in 14.1 pushing on the stair treads.

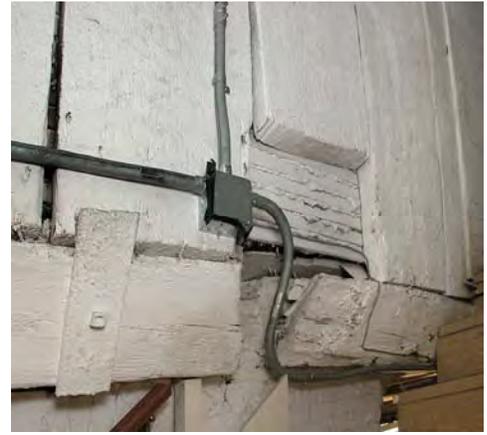
14.4: Detail of splitting and twisted beam in photo 14.1 showing 2" thick wall planks with lath and plaster applied directly to them. Any repair of this condition should use extreme care to avoid damaging the plaster under the wall murals.

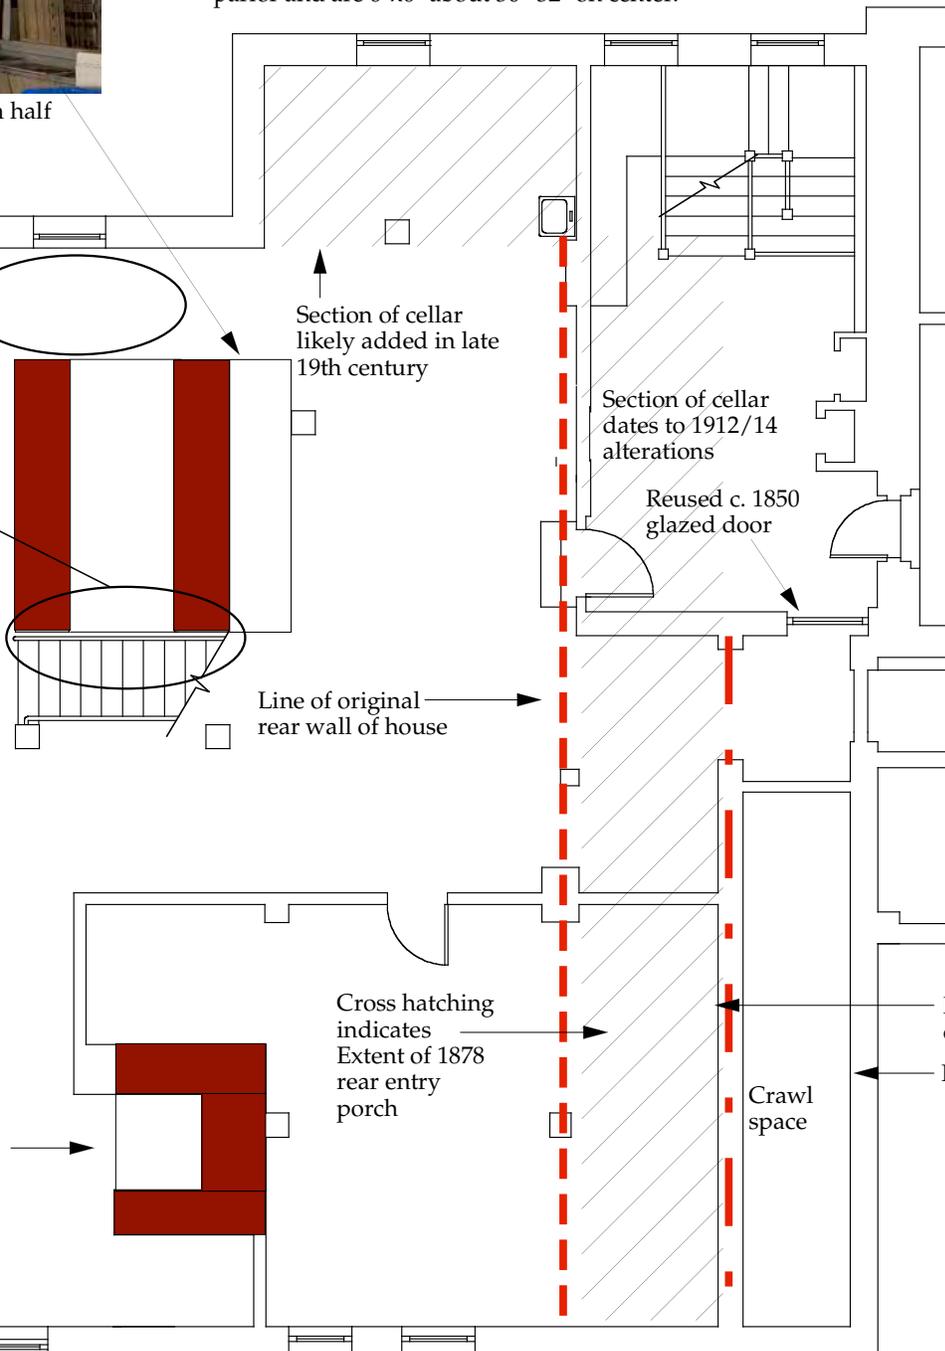
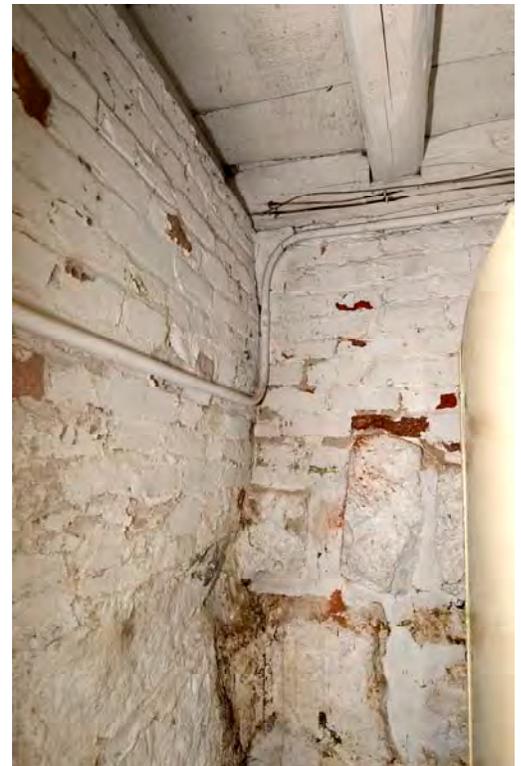
14.6: Southeast corner of original fieldstone foundation. Brick on top of stone are larger in size than 1764 chimney base brick and likely were added in the mid-19th century. Sills appear to be original.
