Existing Conditions Assessment for
SAUNDERS HOUSE

GLOUCESTER LYCEUM & SAWYER FREE LIBRARY

Spencer, Sullivan & Vogt
ARCHITECTURE • PRESERVATION

GLOUCESTER, MASSACHUSETTS
NOVEMBER 2018

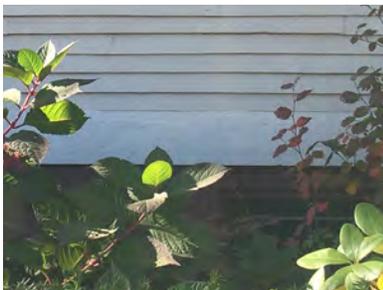
Downspout is emptying directly onto the ground next to the foundation.

- Remove paint from brick via chemical stripping to prevent moisture being trapped behind the paint that leads to brick and mortar deterioration.
- Investigate present locations of downspouts for blockages via a snake camera inspection and confirm clear passage to a storm system or dry well.
- Roof run-off should be controlled to minimize water penetration into the basement through the rubble stone foundation. Perform localized treatments to keep water away from foundation including relocation of downspouts or creation of dry wells.
- Repointing of foundation bricks.

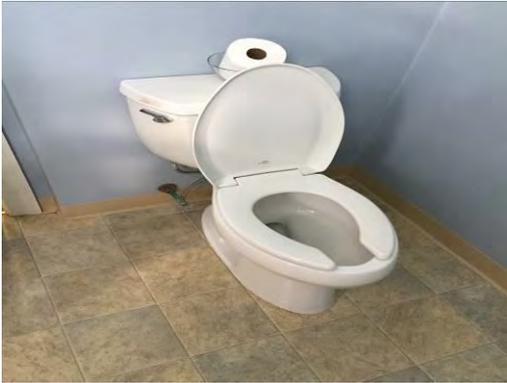
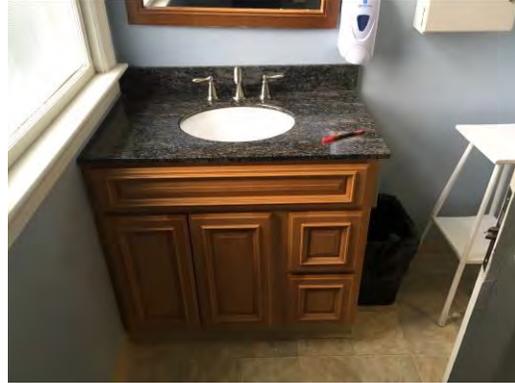
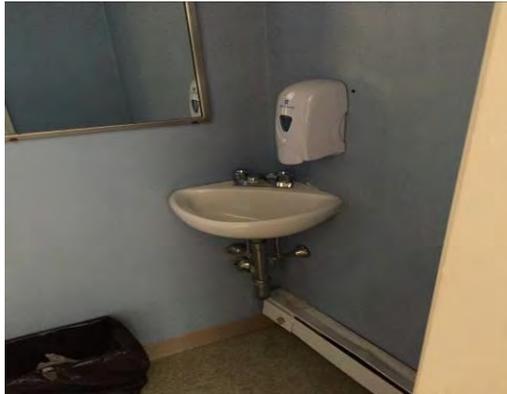
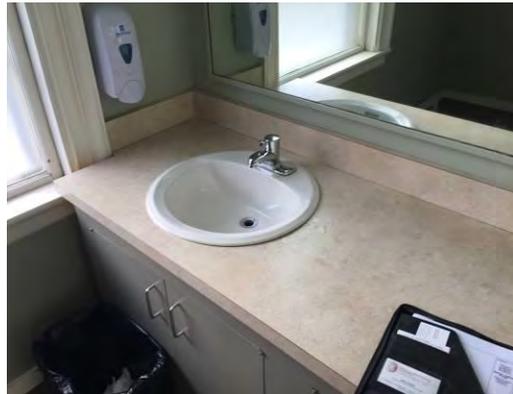
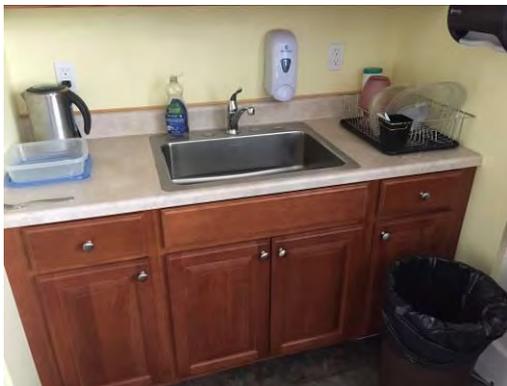
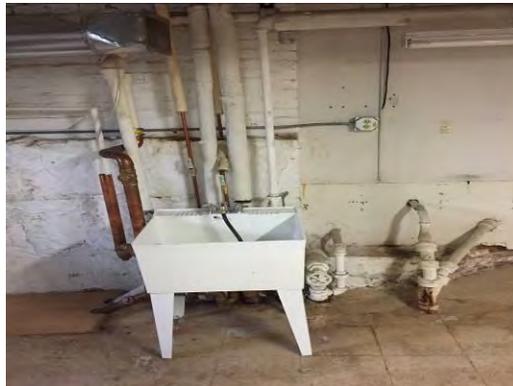
The Plumbing fixtures are in fair condition. Majority of fixtures do not meet current accessibility codes. In general, the fixtures appear to have served their useful life. Current Access Code requires accessible fixtures wherever Plumbing is provided. In terms of the water conservation fixtures, their use is governed by the provisions of the Plumbing and Building Code. Essentially, the code does not require these fixtures to be upgraded, but where new fixtures are installed, as may be required by other codes or concerns, the new fixtures need to be water conserving type fixtures.

1. Video inspect the existing sanitary/waste system for blockage and leaks.
2. Replace all Plumbing fixtures with new high-efficiency low flow fixtures to reduce water consumption.
3. Replace the electric water heater with new high-efficiency gas fired water heater with expansion tank, provide new hot water return pump and new thermostatic mixing valve.
4. Provide all new domestic water piping and valves.
5. Replace existing exterior wall hydrant with new non-freeze type with integral vacuum breaker.

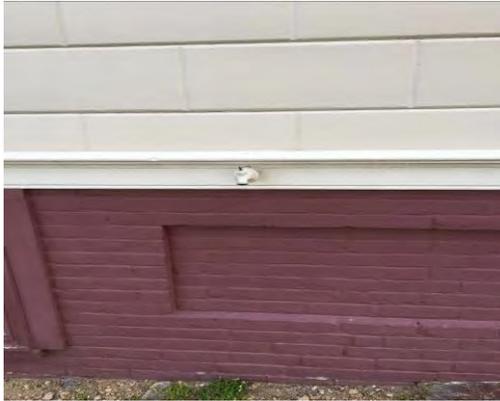
Typical Wall Hydrant

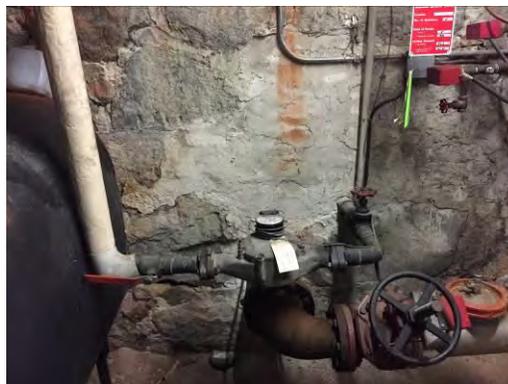
The main domestic water service is located in the Basement Mechanical Room. The service is 2 in. size and includes a 2 in. water meter. The main domestic cold-water distribution is 2 in size. Using the occupancy use of general demand, we feel that the 2 in. domestic water service will be adequate for proposed renovation work.

Domestic Water Service

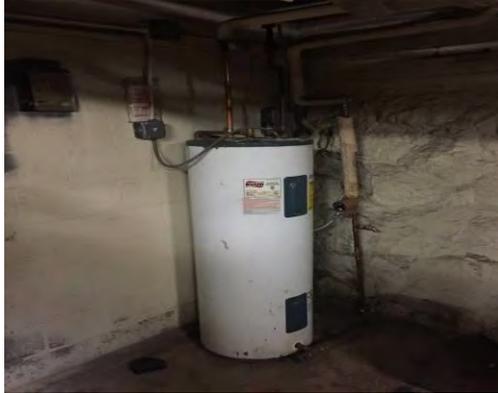
Domestic hot water in the Building is generated through an electric tank type water heater. The hot water system is provided with an in-line recirculated pump system to meet the plumbing code. There is no thermostatic mixing valve or expansion tank on the system which should be provided per code. The electric water heater is 50 gallon storage type, installed in 2006.

Domestic Water Heater

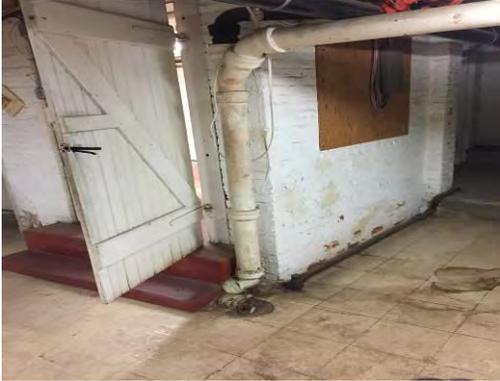
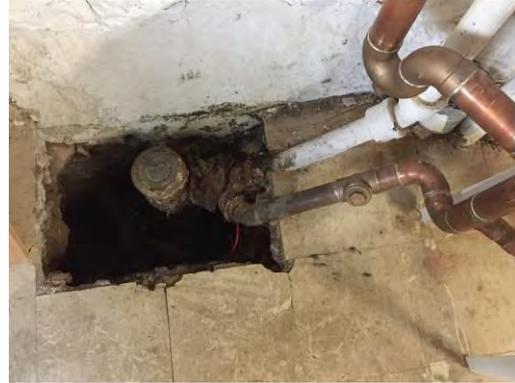
Cast iron is used for sanitary drainage. Where visible, the cast iron pipe appears to be in fair condition. Smaller pipe sizes appear to be copper. In general, the drainage piping can be reused where adequately sized for the intended new use.

Cast Iron Piping

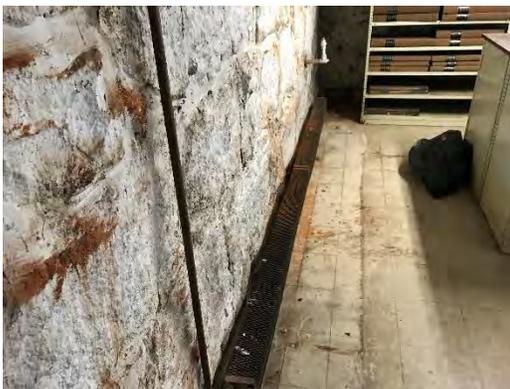
The basement is equipped with hot water fin tube radiation which is fed from exposed copper piping routed to and from an indirect hot water heater within the boiler room. The fin tube and associated piping appears to be in acceptable condition; however, is showing signs of aging, such as discoloration of the pipe, fin tube and fin tube cover. The basement also has been equipped with newer “Healthy Aire” humidification control units.

Typical Hot Water Fin tube

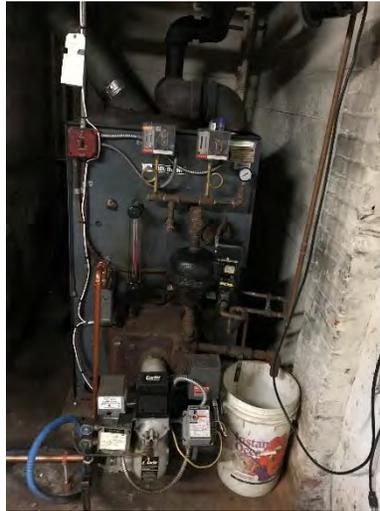
The boiler plant consists of a single cast iron, oil fired Weil-McLain, steam boiler that provides 886 MBH capacity heating to the Saunders House and 1913 addition. The boiler serves steam radiators and a newer hot water heat exchanger serving hot water fin tube radiation in the basement. The boiler plant appears to be well maintained. However, systems will gradually deteriorate to a point exceeding their maximum serviceable life. The boiler is served by an oil-fired burner. Combustion air for the boiler plant is brought into the boiler room through a single louver. Combustion gases are discharged from the boilers into a galvanized metal flue.

Existing Boiler Plant

In an effort to provide code required ventilation, adequate heating and cooling to the Saunders House, a complete renovation of the existing HVAC system is recommended.

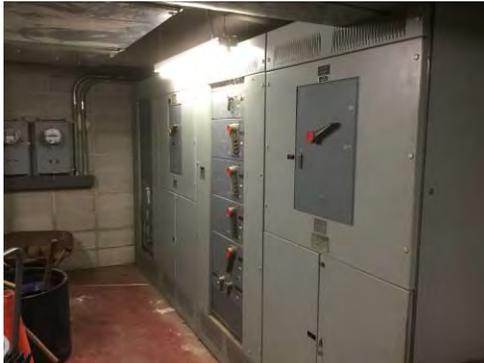
Power for the building comes from the existing panels in the Basement of the 1914 Addition. Wiring is run in conduits through the basement and into the Saunders House and distributed throughout the building. The existing service voltage is 120/208 V, 3 Phase, 4 Wire. The panels that are feeding circuits to the 1764 Building are old and reaching the end of their life expectancy, however are of adequate size if the 1764 Building stays a part of the Library.

Main Switchboard in 1914 Building

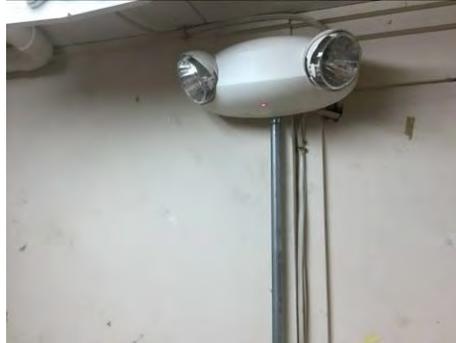
Emergency lighting consists of battery units.

Battery Units

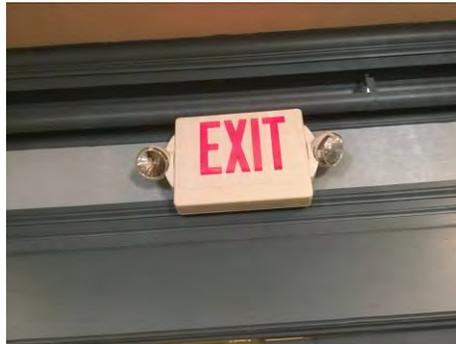
Exit signs have integral emergency heads with battery backup.

Exit Sign

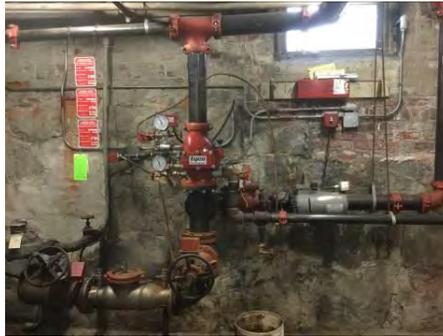
Sprinkler Piping

The sprinkler system is supervised, which means that this system is monitored by the building's fire alarm system.

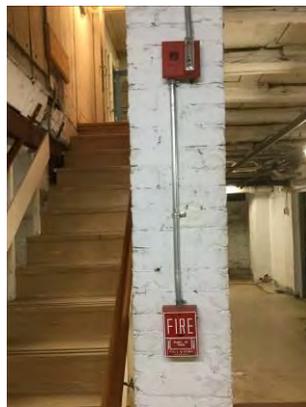
Horn/Strobes & Manual Pull Station

The audio/visual devices consist of horn/strobes throughout but provide inadequate coverage. Manual Pull Stations generally exceed ADA mounting height.

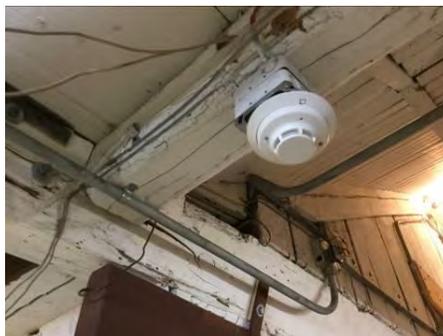
Smoke Detector

Smoke detectors exist throughout corridors and stairwells.

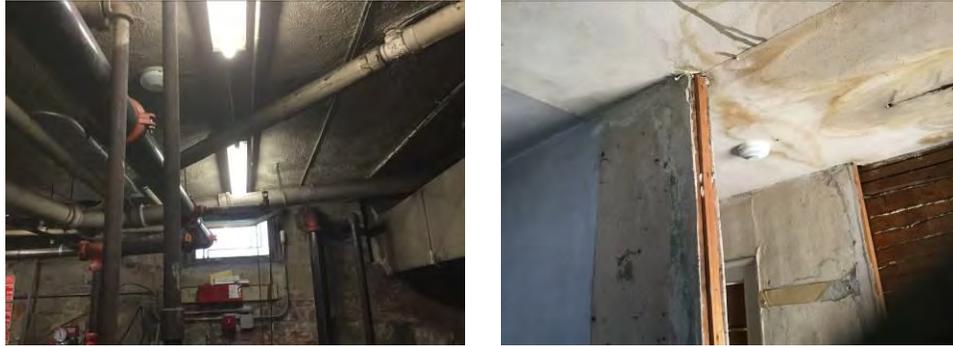
Heat Detectors

The facility is sprinkled and therefore full coverage of smoke detectors is not required by code. Heat detectors exist in the Boiler room and in the upper level.

The fire alarm system does not meet code and has inadequate coverage.

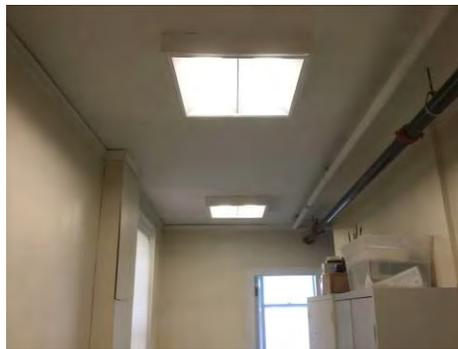
Interior Lighting

The interior lighting was upgraded during 2013 but the existing wiring switches were reused. The corridors and open office areas have 2x2 surface mounted channeled troffers.

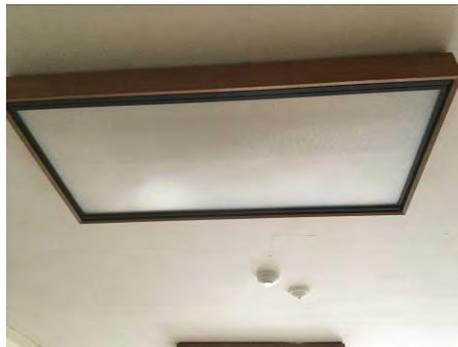
Surface Mounted Fixture

The Meeting room has recessed 2x4 surface mounted fixture.

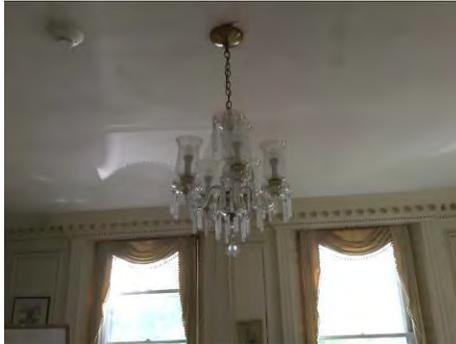
Conference Rm. Period Chandelier

The Conference Room has a period chandelier with LED bulbs.

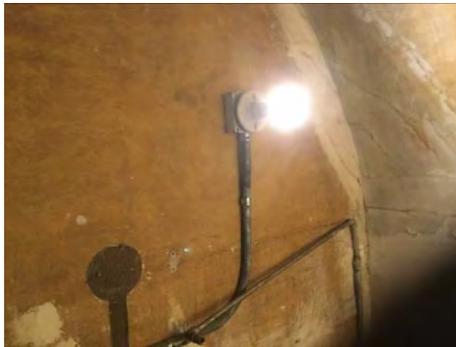
Surface wall fixtures

The upper floor lights consist of surface wall keyless porcelain fixtures.

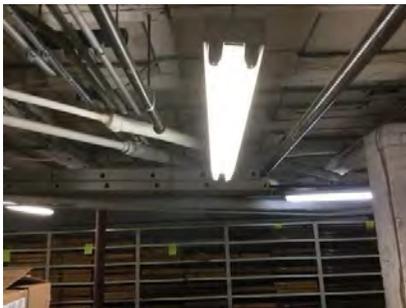
Open Channel Strip

The utility rooms and basement have open channel strips with two T8 lamps and wraparound fixtures. (Some with lenses missing)

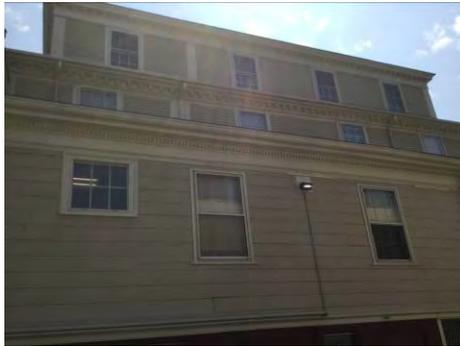
Exterior LED Fixture

The exterior lighting is a wall mounted LED fixture and a surface mounted residential fixture at the Front Entrance.

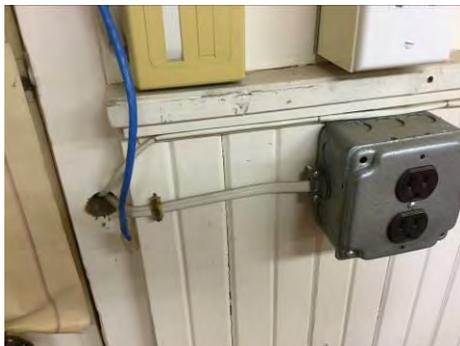
Romex cable

Some receptacles are fed with Romex cabling which is not used in Commercial Buildings. Minimal receptacles in Office areas require the use of plug strips.

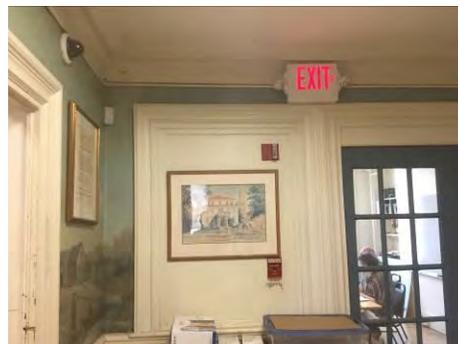
Motion Sensor & Camera

The building has a security intrusion system fed from the main building motion sensors, cameras, and door contacts were observed.

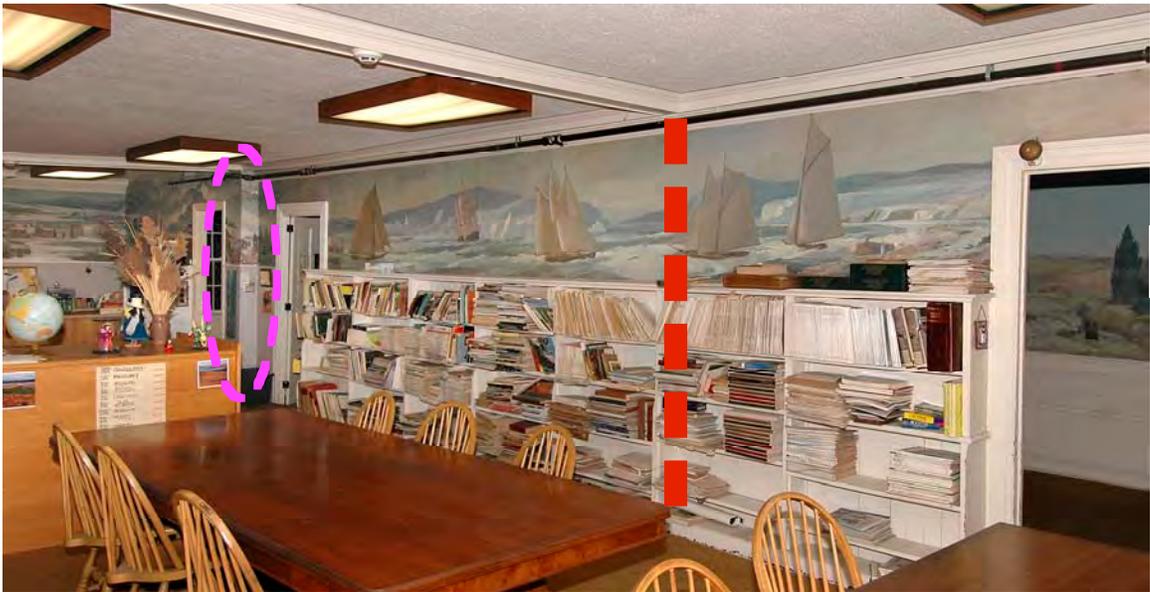
The partition shown on the drawing to create a separate office in the front of the current large room intrudes on the most cohesive and impressive part of the wall mural in this space as shown by the red dashed line. Flipping the arrangement of the room to place the separate office at the rear would place the partition where there is already a break in the wall (purple line) and would also provide a means to support the severely sagging ceiling beam at this location.

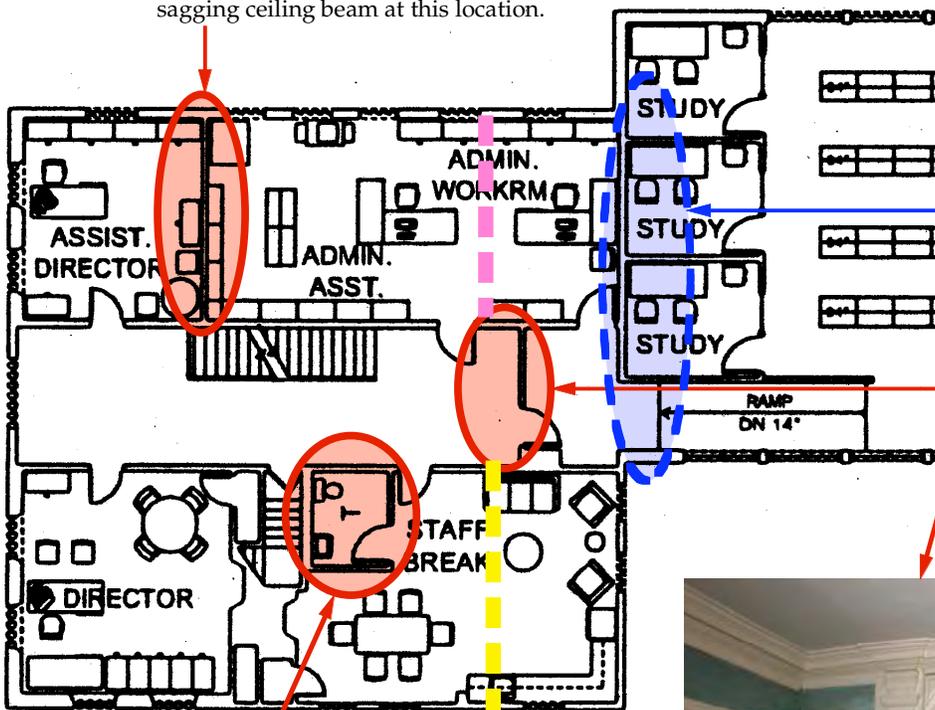
Creating a full second floor on the 1912 stack wing and connecting it to the house will likely cover much of the existing 2nd floor roof and cornice at the rear of the Sanders House. This should be done in way that preserves the cornice and dentils intact within the addition to the greatest extent possible, particularly if further investigation reveals that the original 1764 dentils and cornice woodwork was reused when this section was added in 1914.

Creating the passage from the center hall to the new addition as drawn would require the removal of the original 18th C. arched window and pilasters shown below that is the major architectural feature of the hall. The circulation path should be through the staff room instead.

Placing the bathroom in the staff room corner may result in damages to historic finishes from running new plumbing and vent stacks on both the first floor and third floor. It would be better to keep all plumbing within the 1914 addition on the rear of the building.

Complete removal of the rear wall of the current staff room (yellow line) to enlarge the staff room as proposed has structural consequences regarding the support of the 3rd floor wall and roof directly above. Although the plaster current finishes on this wall are modern, we presume the original 1764 structural elements remain under the plaster.

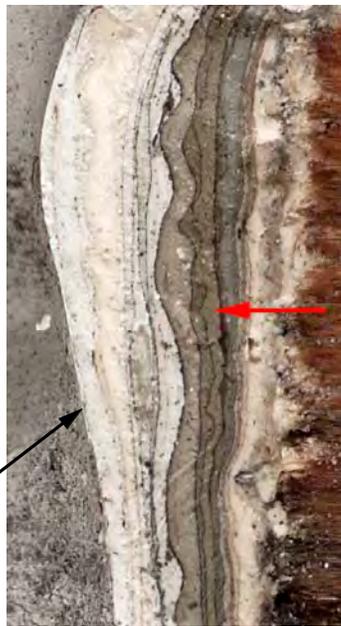
2.7: Cross section of paint from dentil on pedimented window head. The red arrow points to the layer that was exposed at the time of the 1914 alterations (based on an 1802 exterior window frame that was enclosed by the 1914 addition). It is clear in comparing the paint from the two elements that the window head is no later than 1802, but the earliest layers of white paint are so deteriorated that it is difficult to determine if there is pre-1802 paint on the dentil.

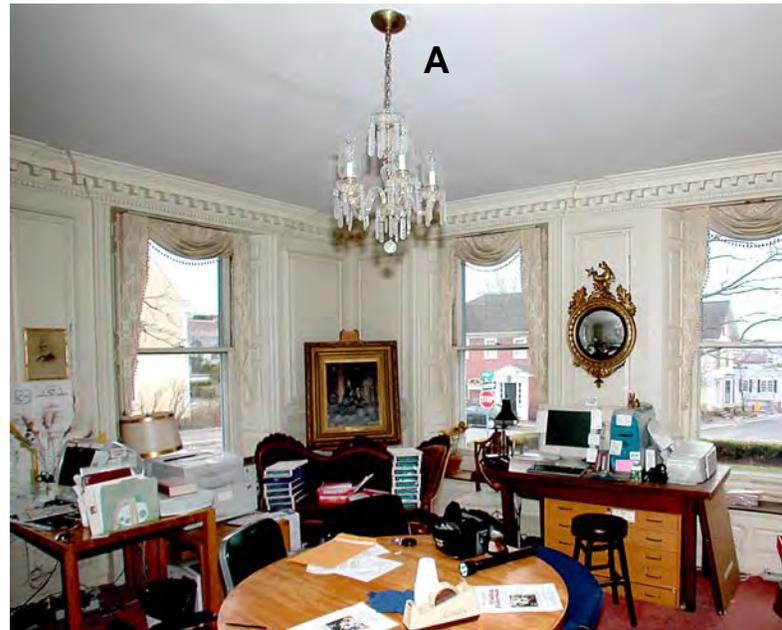
3.2: East and west walls with bolection molded panels. The circular scars indicate that a Victorian plaster center rosette was removed in the early 20th century.

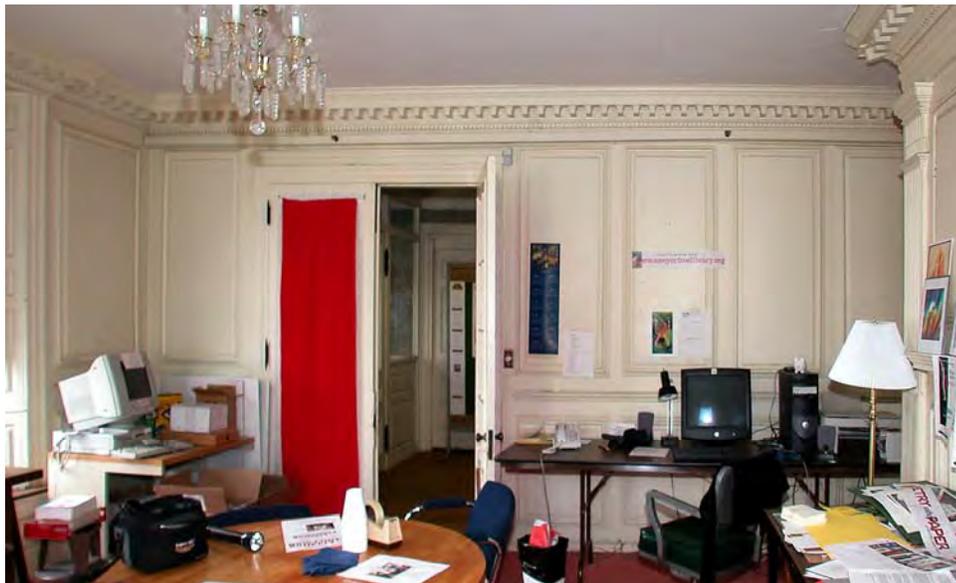
3.3: West wall – The original doorway to the center hall would have been for a single door, and was widened for double doors in the late 19th century. Based on scars at the chair rail to the right of the door frame, the original door opening was on the left side.

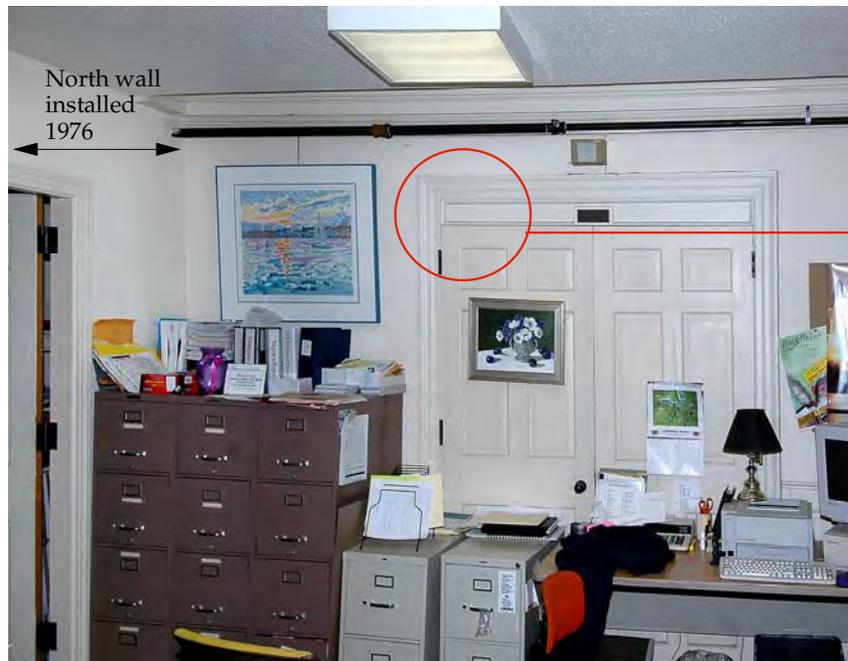
4.5: East wall showing widened door frame installed in 1914 or possibly in 19th century. The door was replaced in 1976 likely matched the French doors to the SE parlor across the hall.

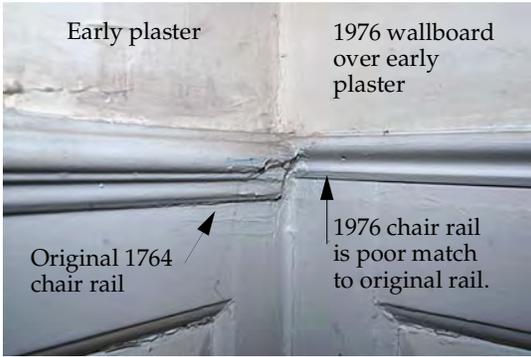
4.2: Detail of wainscot and plaster at SW corner showing poorly executed 1976 "restoration" of west side chair rail and plaster. East wall is similar.

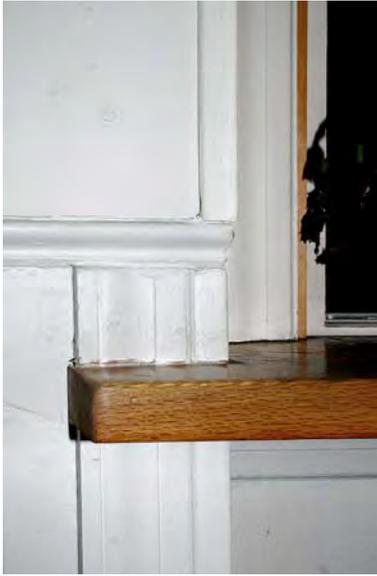
Detail of window
sill and sill at west wall
showing awkward use of
moldings in 1976.

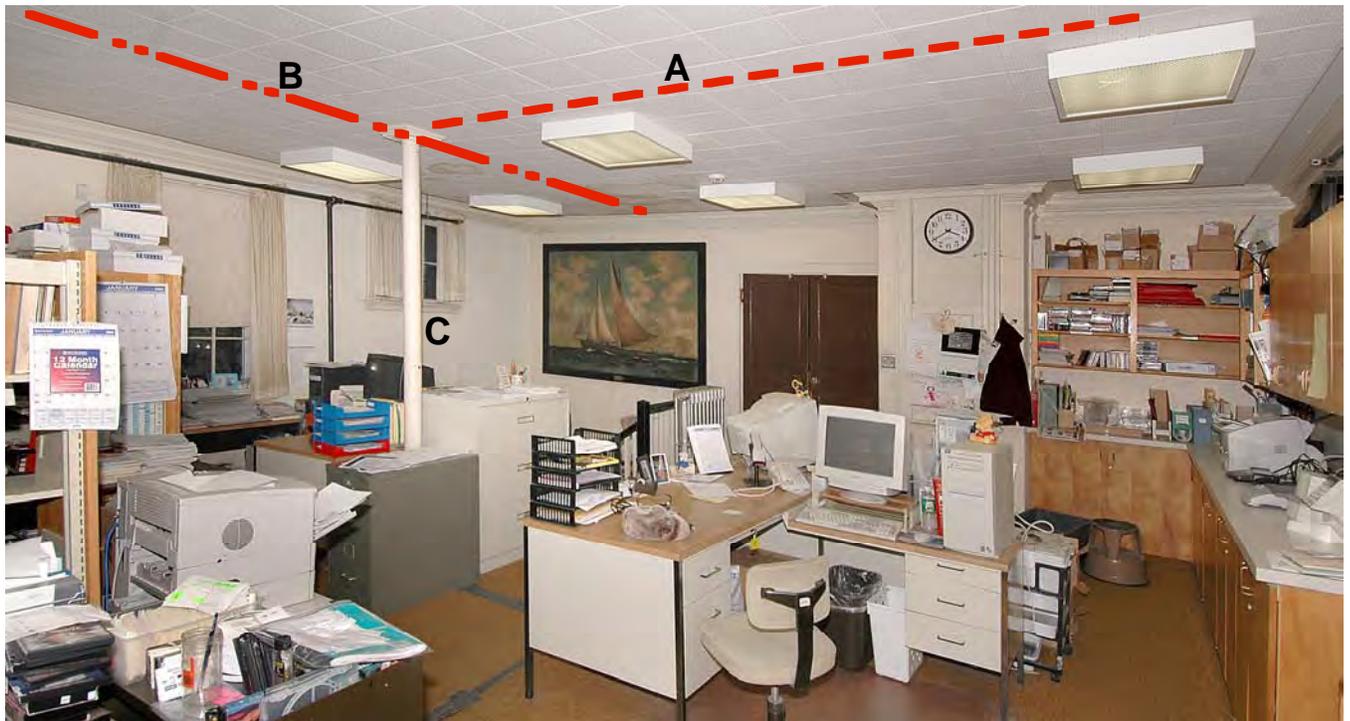
5.1: Northern end of work room – The current configuration of this room dates to the 1912 and 1914 alterations. "A" is the line of the rear wall of the original house, and "B" is the line of the original west wall of the house. The area to the left of line "B" is in the one story west ell. The load of the 2nd floor west wall of the house is apparently carried the lally column "C" and another one that is out of the photo. The 1914 drawings called for an entire new ceiling in this room, and it is likely the ceiling structure was reworked at that time. The only decorative detailing in the room is the 1914 wood cornice around the ceiling (see 5.2). The window casings and sash date variously to 1914 and 1976.

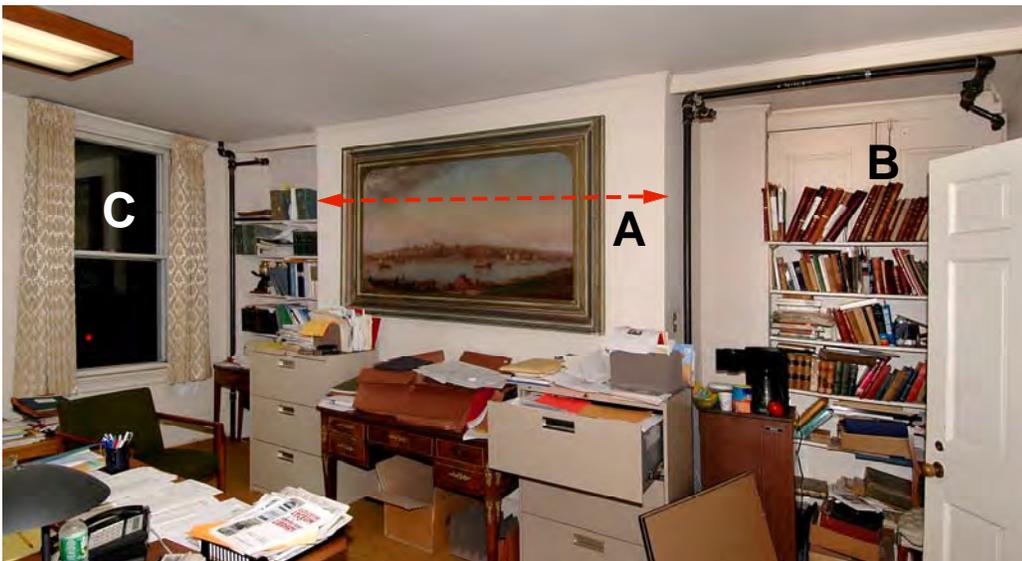
5.3: South wall of the Northeast room on the first floor – The chimney breast marked "A" is entirely covered with wallboard or plaster installed in 1976. Originally there would have been a fireplace in this location. It is not known if any elements of that fireplace and related woodwork survive behind the modern finishes (no holes were cut into it for investigation). The back side of the paneled doors from the southeast parlor are exposed behind the bookcase at "B". The east wall at "C" dates to 1934 when the 1878 bay was removed to restore the original external appearance of the house.

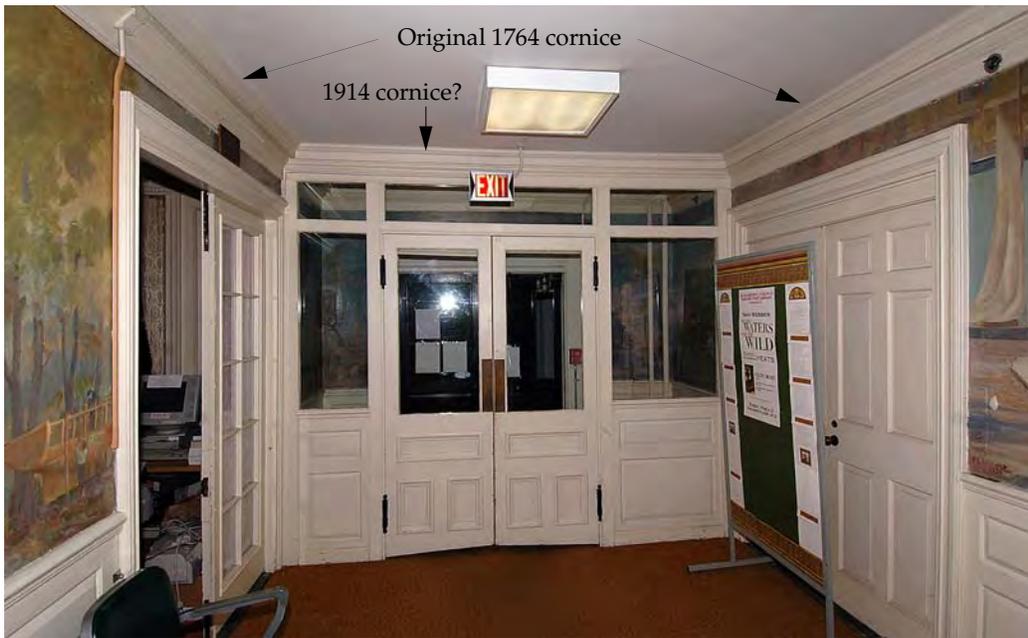
6.1: South end of stair hall – The inner doors with sidelights, transom, and panels all date to 1914 or 1934. The cornice over the transom windows is presumed to also date to 1914, but its paint was not checked. The door frames in the side walls date to 1914, but the doors in the right hand frame leading to the SW parlor date to 1976 when the frame was blocked down.

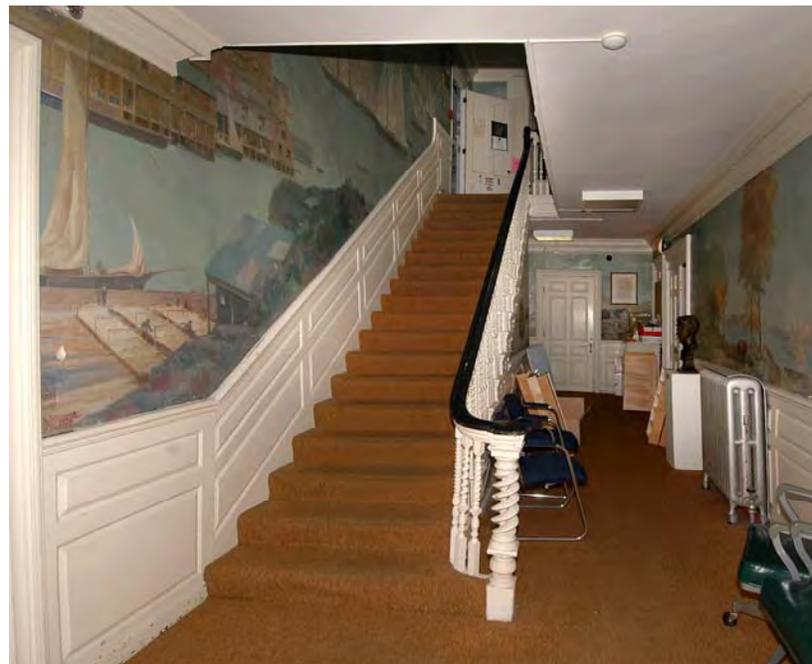
6.5: Overview of stair hall – The stairs with its turned balusters, the paneling and the cornice are all original to 1764. The wall murals were painted by John in 1934. The visible lean of the newel post is due to a structural problem in supporting the left hand wall (see sheet 14 for details).

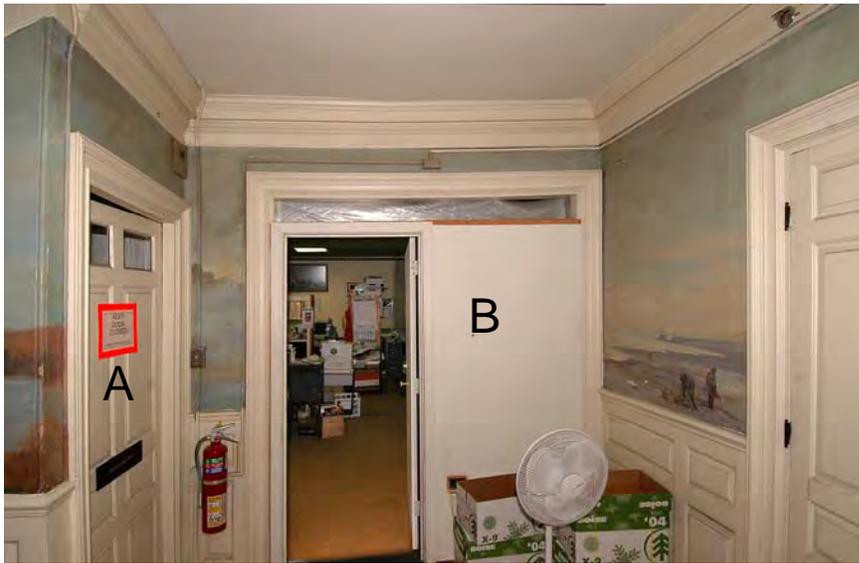
6.6: Rear of stair hall – cellar door on left (A) is 1764 door in a 1914 door frame. Door frame in center to workroom (B) dates to 1914, but was blocked down in 1976 with a single leaf door and solid panel. The cornice and wainscot panels date to 1764, but show evidence of being reconfigured to adapt to minor changes in plan.

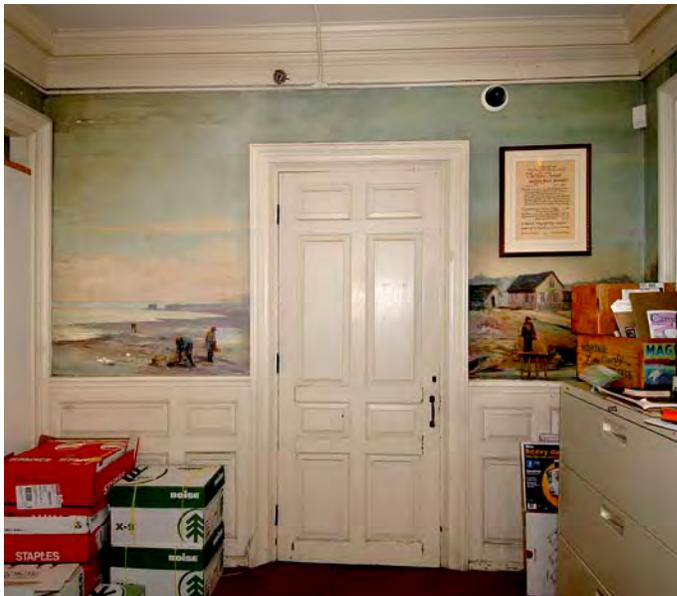
6.7: Rear of stair hall – Door in rear wall dates to 1764, but its door frame dates to 1914 or 1934. The wainscot is also original to the hall but has been reworked to accommodate the current door (the two narrow panels may have been cut down from larger panels that were removed to widen the other hall doorways). As this was made a major entry in 1878, it may have been made wider with two door leaves at that time, and then was restored back a single door in 1914 or 1934. The wall is the original rear wall of the house.

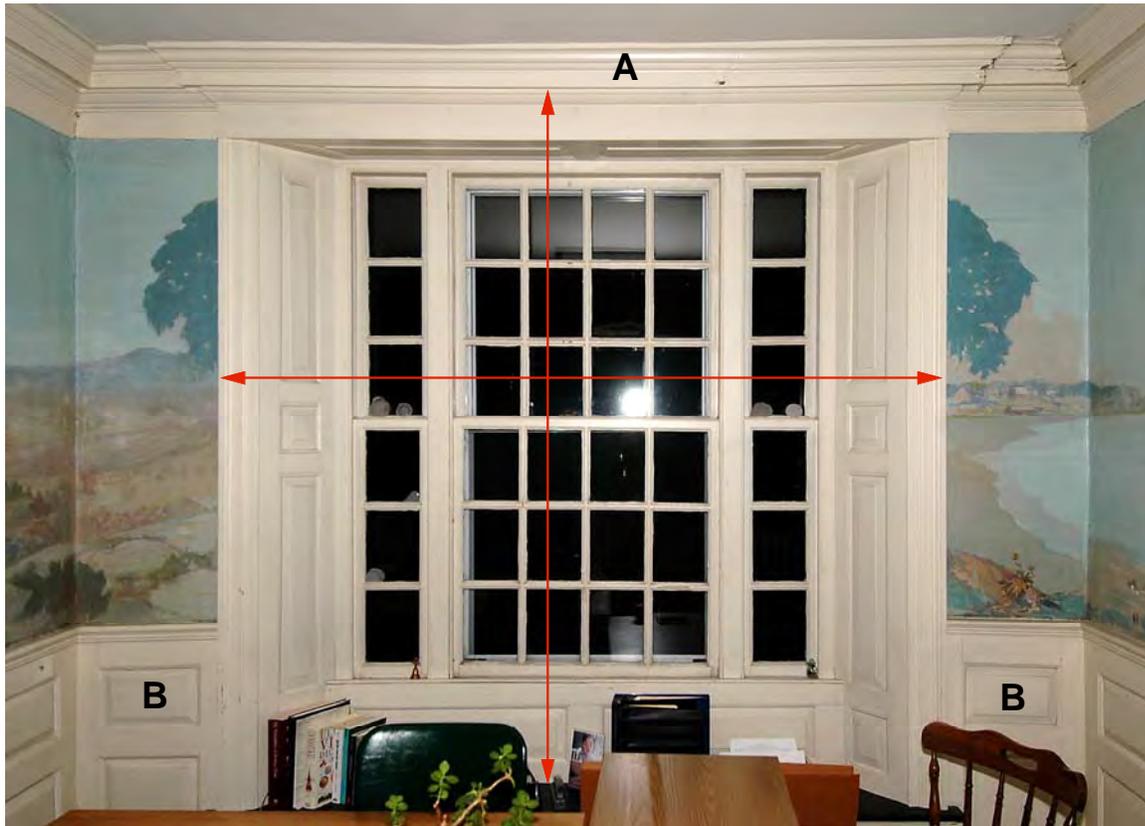
7.1: South wall – The window and paneling (red arrows) were installed in 1934 following removal of the 1878 entry tower. The 12/12 sash is a correct restoration of the 1764 sash, although the basis for the sidelights and overall width of the opening is not clear. The cornice (A) above the window is original. The flanking panels (B) are original, but were reduced in width in 1934 to accommodate the new window.

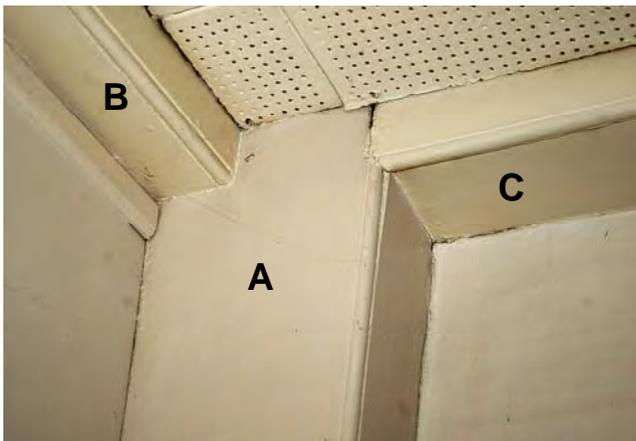
9.1: Detail of original 1764 corner post (A), rear roof plate (B), and end wall girt (C) with original beaded casings still in place. Note ceiling plaster has been covered with modern acoustical tile. Examination of this ceiling from 3rd floor above indicates the plaster remains in place on accordion type wood lath, and likely dates to 1802.

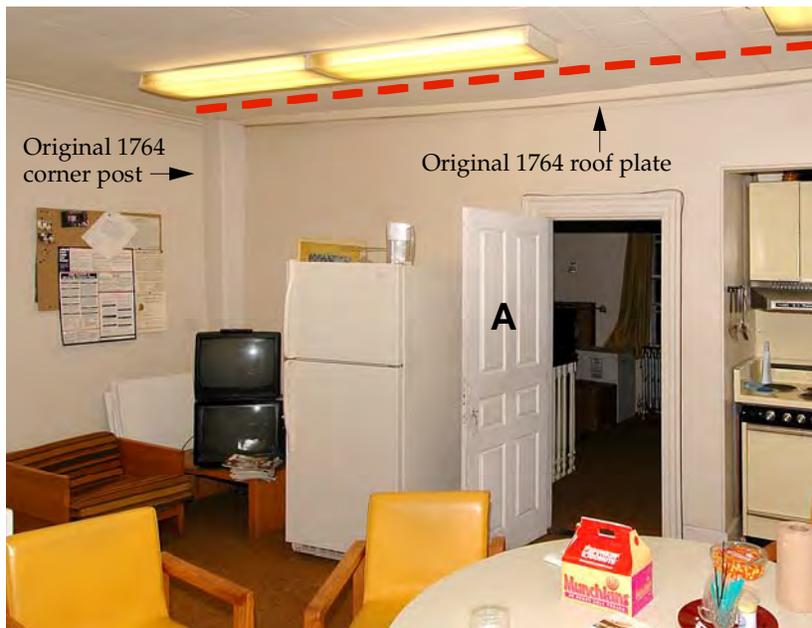
9.2: North wall – This is the original rear wall of the 1764 house. Its plaster surface and original framing is likely still present behind the plaster. The original roof plate casing is visible at the top of the wall, and the cased corner posts at the kitchen niche was cut into the wall in 1976. The door (A) dates to 1802 and was installed on the third floor in 1914. The 1802 third floor rear wall and roof bears on the ceiling joists at the approximate location marked by the red dashed line. Camera lens distortion could be sagging in this photo, but in reality it does not show deflection.

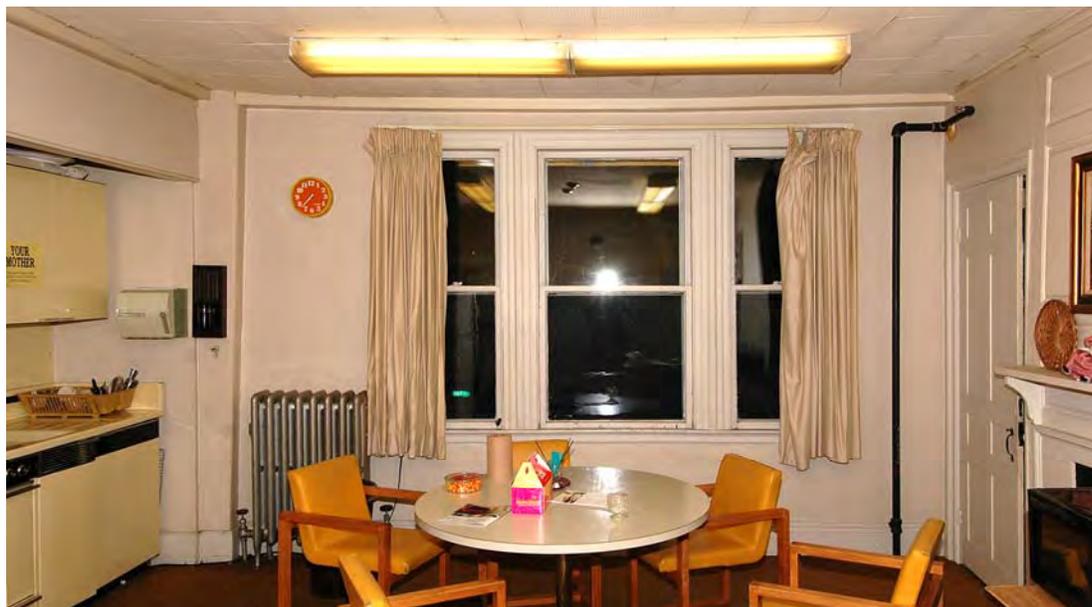
9.3: East wall – The triple window configuration was installed in the 1914 alterations and has the typical 1914 type 2 casings. According to the 1914 drawings, the center pair of sash was reused. The original cased end girt is visible at the top of the wall. The rear corner post on the left tapers to be wider at the top in order to receive the structural wall and roof members that originally framed into it.

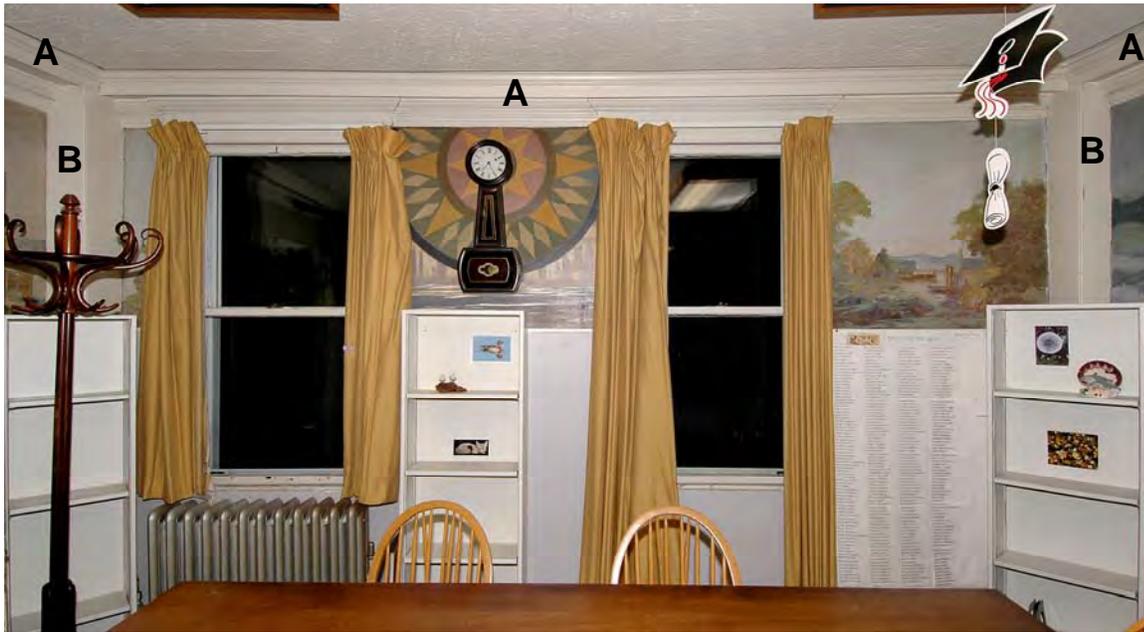
10.1: South wall. The cornice (A) and corner posts are original to 1764, but the window casings are 1878 or 1914. Note that the cornice breaks forward over the windows.

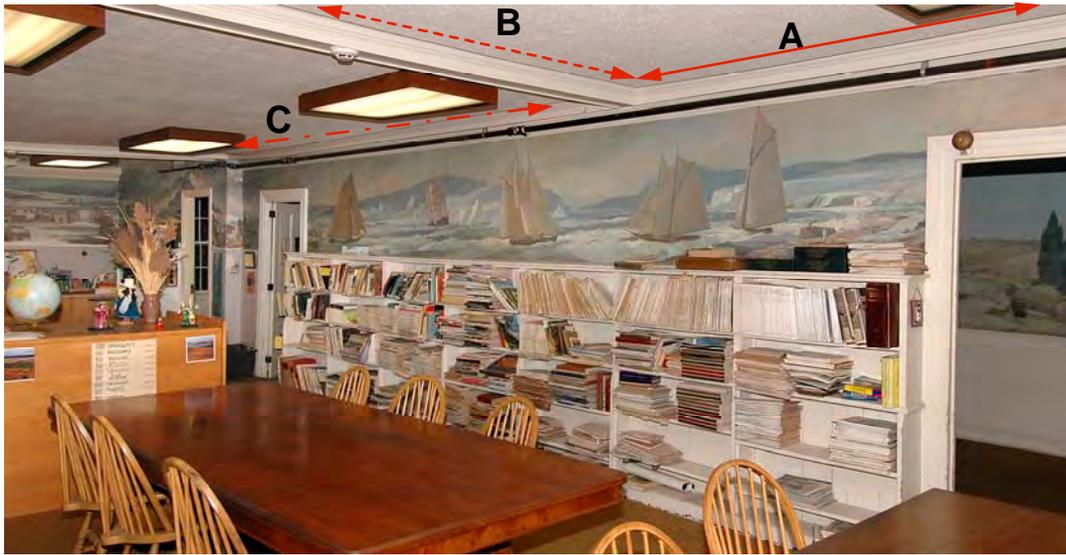
10.2: East wall showing the most cohesive section of the 1976 wall mural. The bookcase also contributes to the character of the room. The section of cornice marked "A" dates to 1764; the sections "B" and "C" are accurate copies from 1914. The section "B" is on the line of the original fireplace wall of the SW chamber.

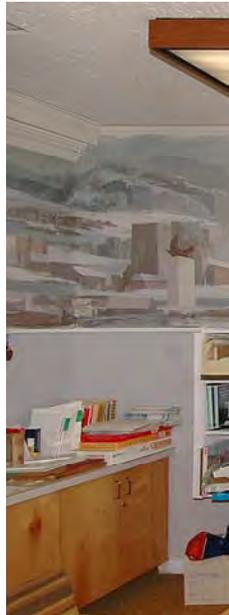
10.4: Detail at junction of mural to the lower wall and window casing. Wallboard (A) was applied over the lower portion of the wall plaster in 1976 as an expedient repair, but the murals were apparently painted directly on the old plaster. The plain board window casings is typical of most 2nd floor casings from both 1764 and 1878.

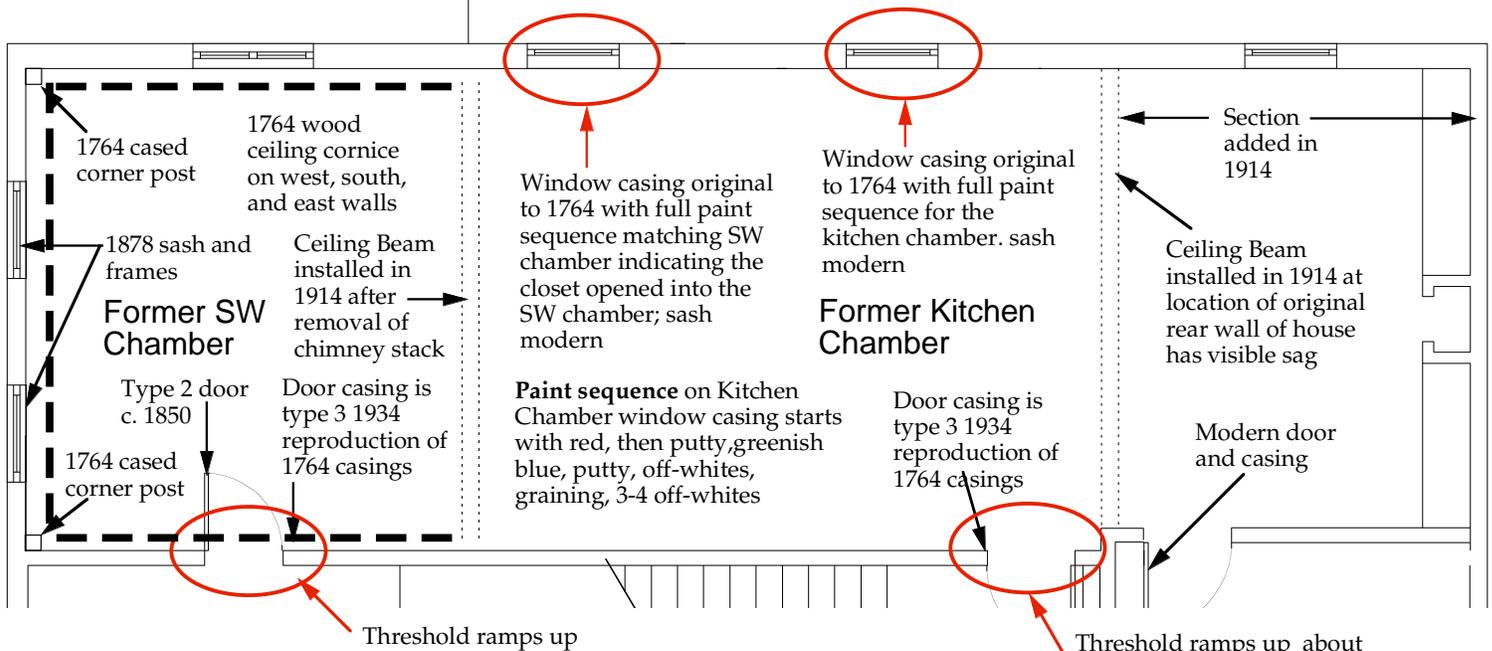
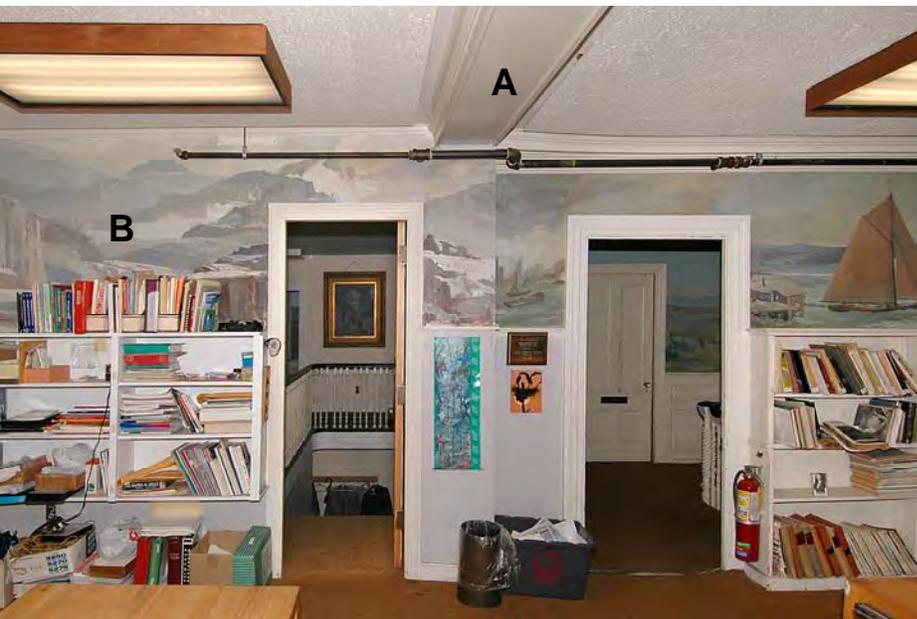
Threshold ramps up about 2" from hall to floor of community room. 1914 drawings call for sound deadening at the community room floor; perhaps the height difference is due to that.

10.3: East wall at junction between original house and the 1914 rear addition. The rear addition as shown on the 1914 drawings did not include the north end of the community room (then the Children's room); apparently the plans were changed during construction to extend the room to its current configuration. As the section of wall marked "B" lacks a cornice and its door to the rear hall does not conform to the 1914 work, it may have been reconfigured later in the 20th century. The beam marked "A" carries the rear wall of the third floor above and currently has a substantial visible sag in its center.
