Existing Conditions Assessment for
SAUNDERS HOUSE

GLOUCESTER LYCEUM & SAWYER FREE LIBRARY

Spencer, Sullivan & Vogt
ARCHITECTURE • PRESERVATION

GLOUCESTER, MASSACHUSETTS
NOVEMBER 2018

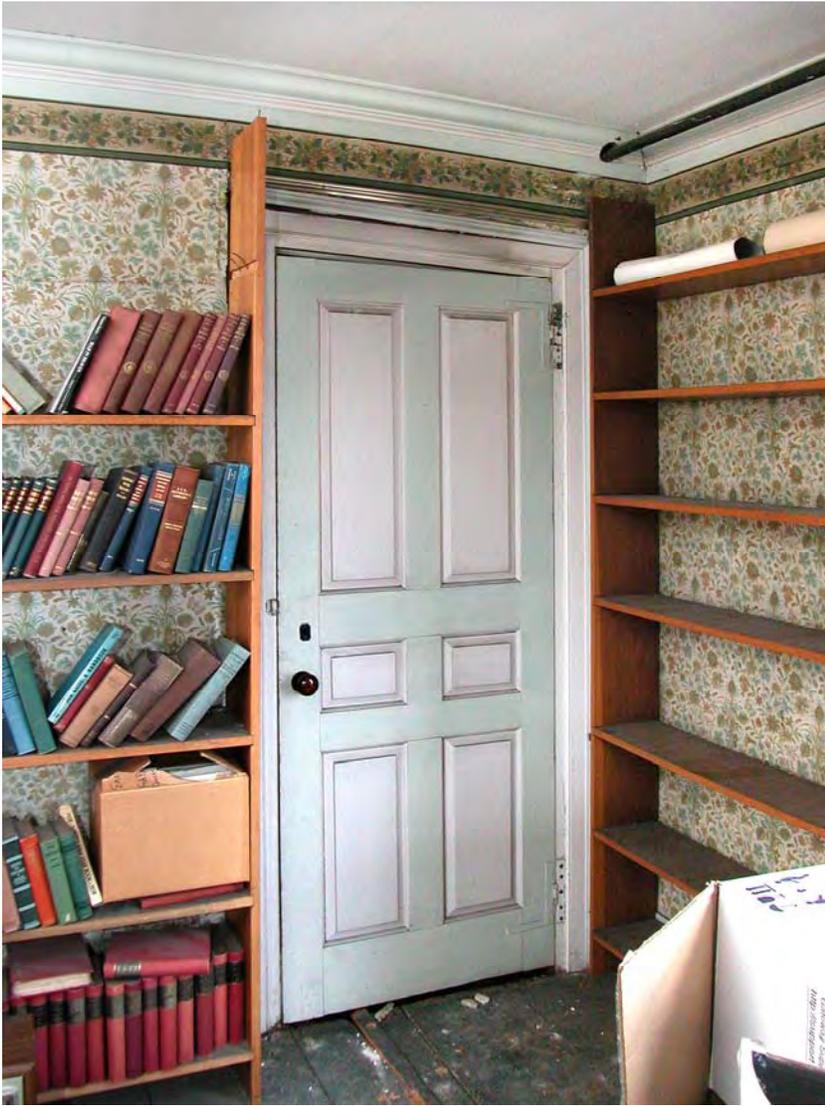
11.1: SE attic chamber showing 1878 wallpaper and two tone paint scheme on woodwork. 1878 paint is applied over the graining that is still exposed in the NE chamber (see 11.2). The woodwork detailing is conservative for 1802, as the raised panel doors and crown moldings at the ceiling are more Georgian than Federal in character. Door retains original 1802 HL hinges.

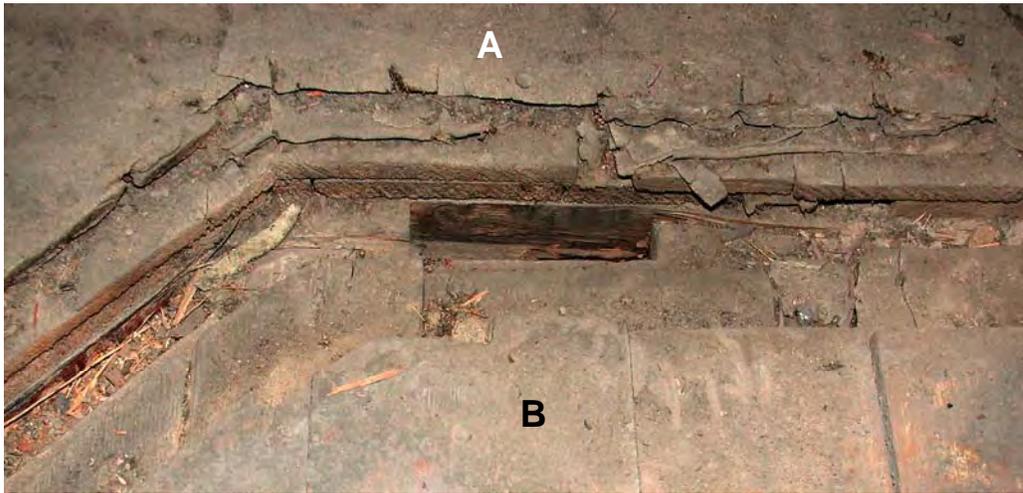
12.5: Detail of recess in attic floor that housed the observatory exterior wall. "A" marks the 1802 canvas and mastic roofing that remains in place. "B" marks the observatory floor.

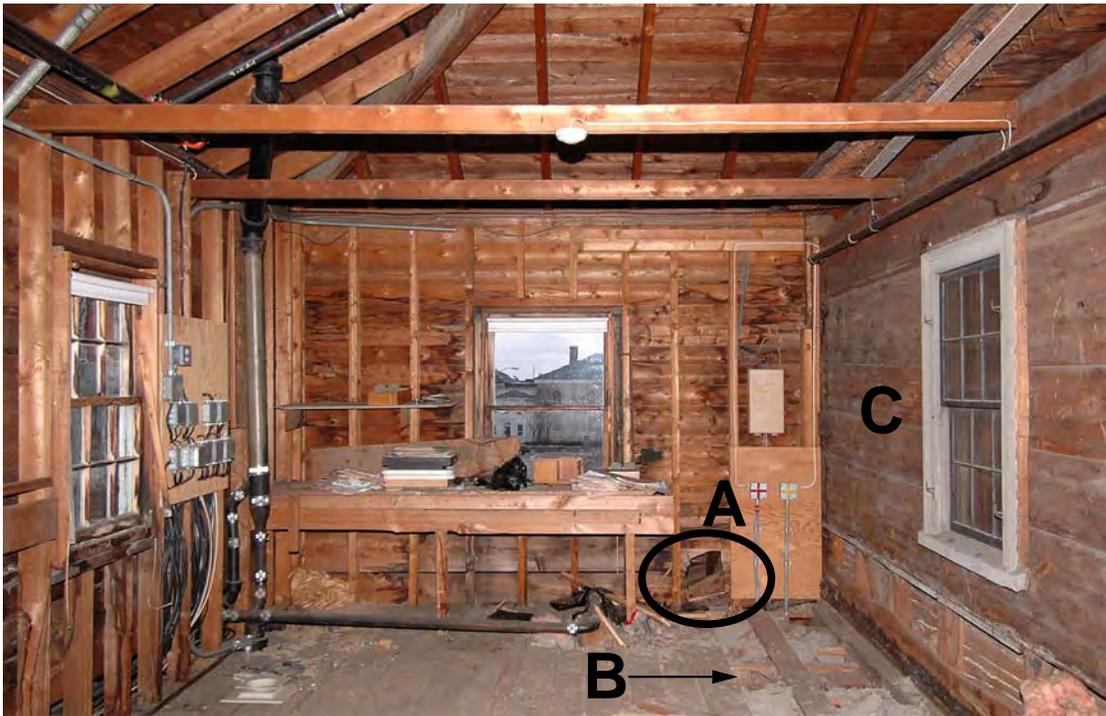
13.1: Unfinished third floor of 1914 rear addition showing area of framing exploration. The circle at A marks the hole cut in the wall sheathing that was used to take the photo at "A" on the plan. The arrow at B points to the ceiling beam "B" in the photo 13.3. "C" marks the original rear wall of the 1802 addition. The clapboards and cornice were removed from the wall in 1914. The window frame on the right wall dates to 1802 and has not been painted since 1914.

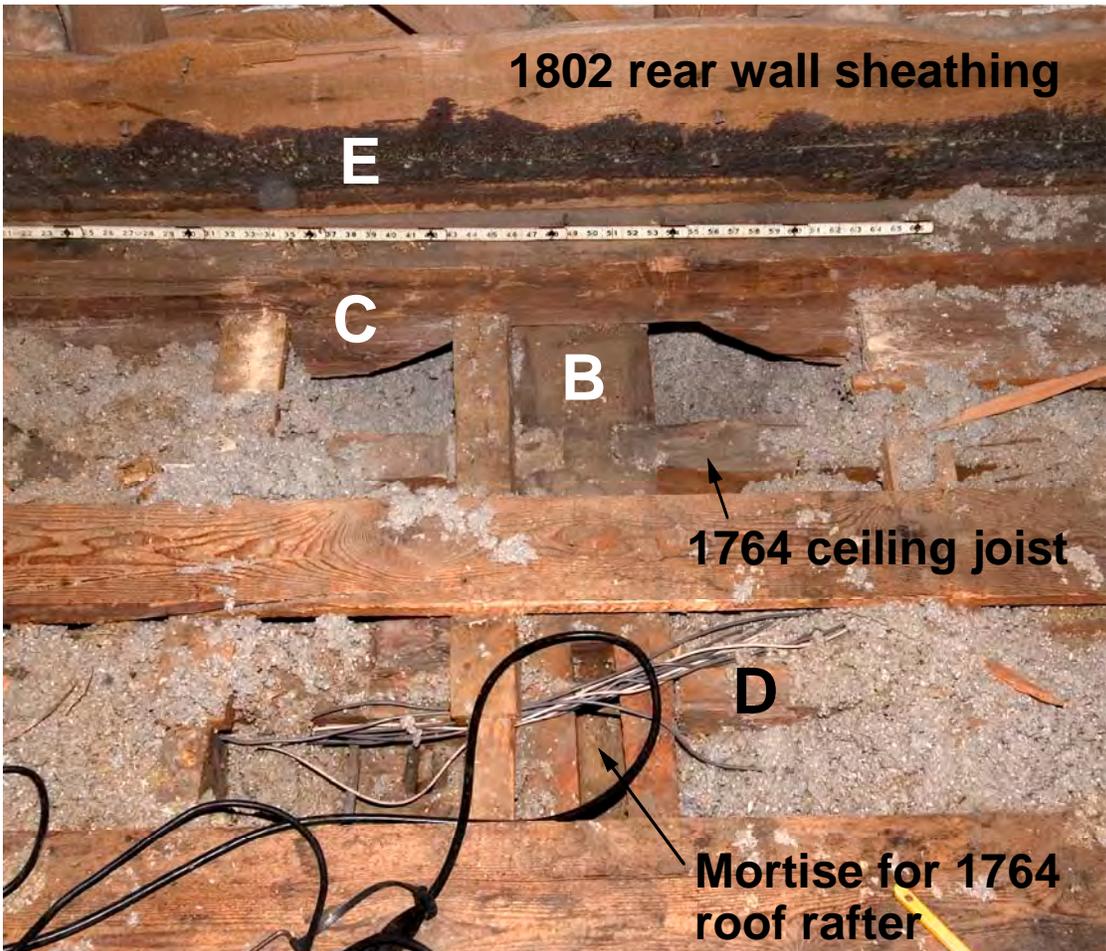
13.3: Framing at 1802 rear wall showing how 1802 rear wall plate (C) is notched over a 1764 ceiling beam (B). The ceiling beam carries the 1802 wall load to the original 1764 roof plate (D). The mortise in beam "B" for an original 1764 roof rafter is 13" long, indicating the rafter had a fairly low pitch and was unlikely to be for a gambrel roof. The dark material at "E" is tar from the original 1802 tarred canvas roof. See the drawings 13.5 and 13.6 at right for a plan and section through the wall plates.

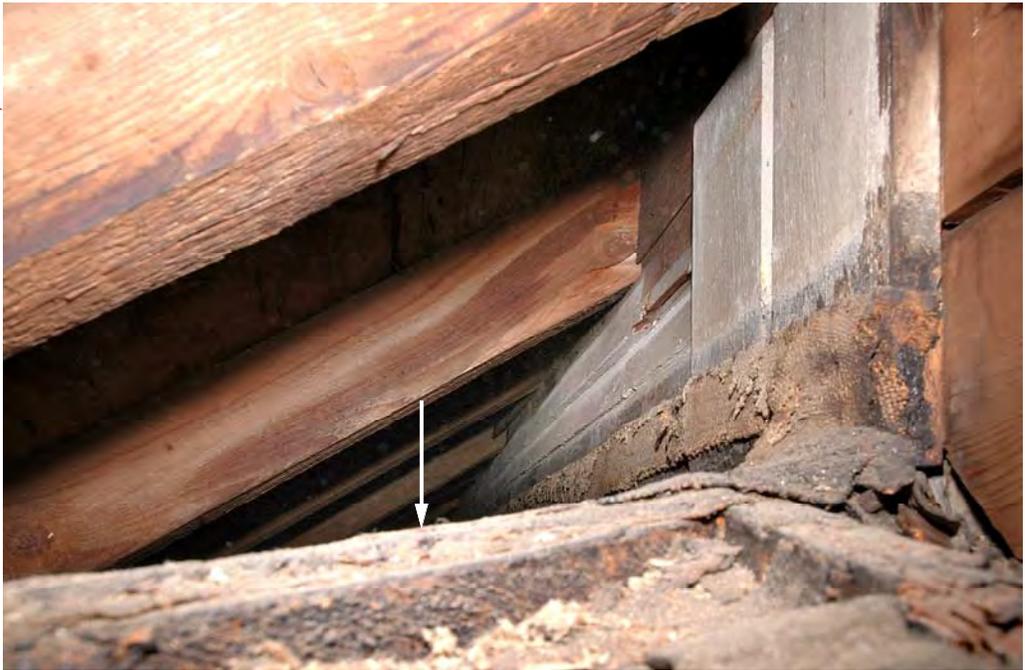
13.2: View under c. 1830 roof taken at "A" on the floor plan showing surface of low pitched 1802 canvas roof (arrow), with white 1802 clapboards and corner quoin still in place at right. The tan material at the base of the clapboards is the 1802 canvas turned up the wall as flashing. It was probably covered by a base board that has been removed.

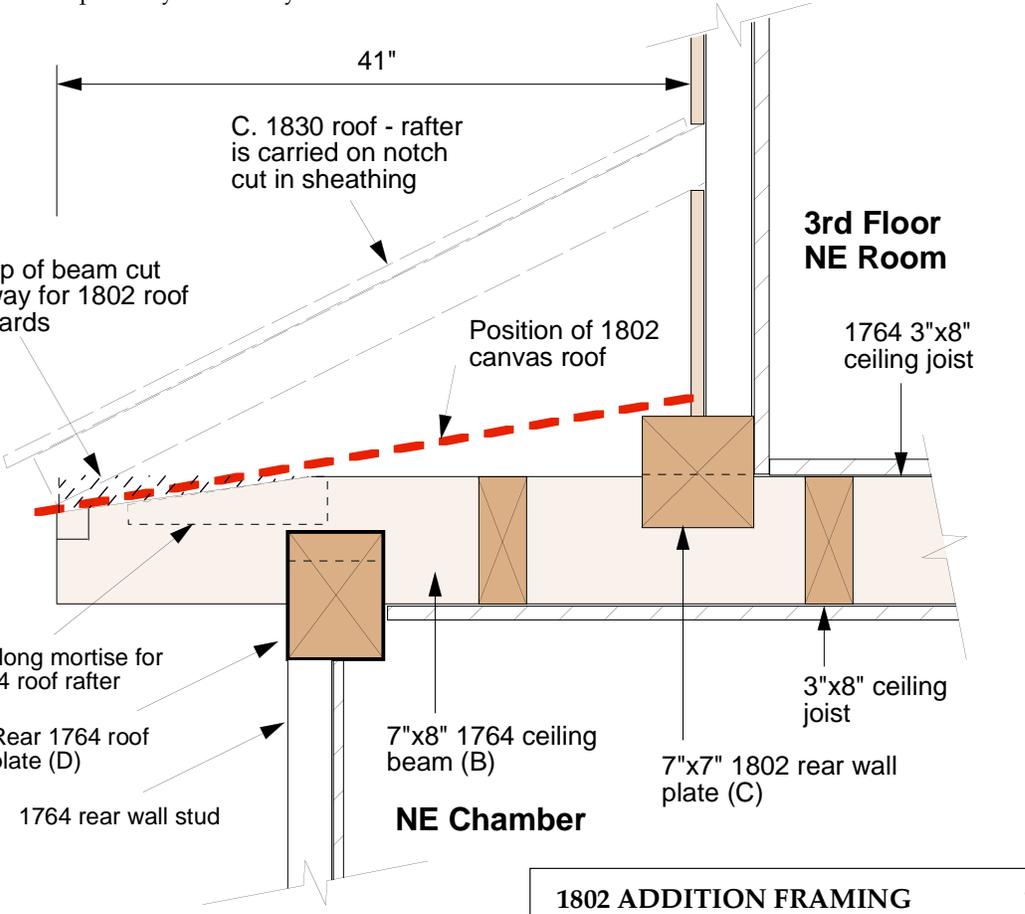
13.6: Section through 1764 roof plate and 1802 wall plate showing how 1802 rear wall plate (C) is carried by 1764 ceiling beam (B). The ceiling beam carries the 1802 wall load to the original 1764 roof plate (D).

1802 wall plate (C) notched over beam B) and 1802 framing at NE corner of 1764 polygon beam that suggests original roof was ambrel. End of plate "C" just barely laps with minimal bearing. Scale 3/16"=1'

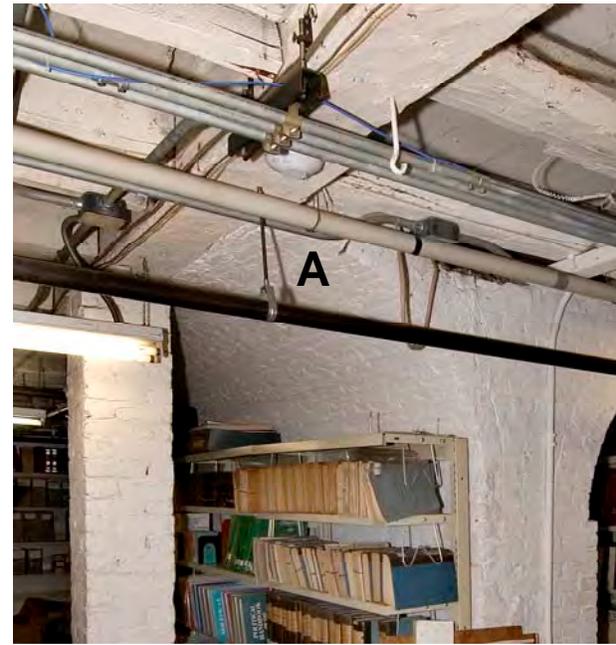
14.2: Base of westerly chimney still remains in place with arch (A) that originally supported the kitchen hearth.

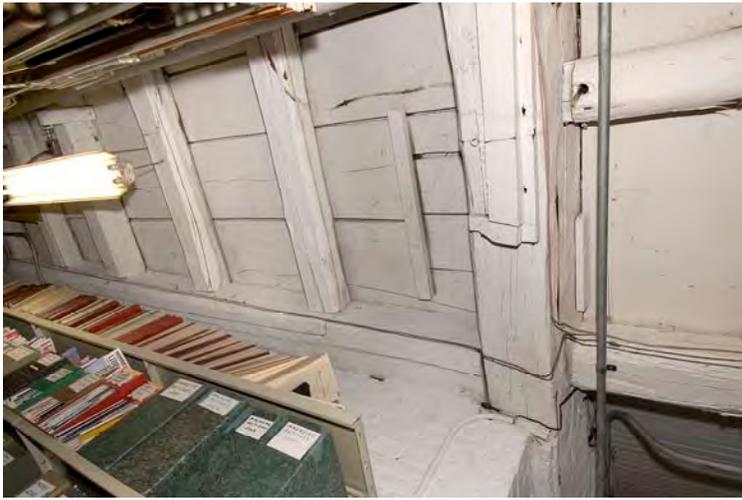
14.3: Typical framing for first floor. Joists shown are under SW parlor and are 6"x6" about 30"-32" on center.
